## Nine materials present in ecalgeo.g21

### Method:

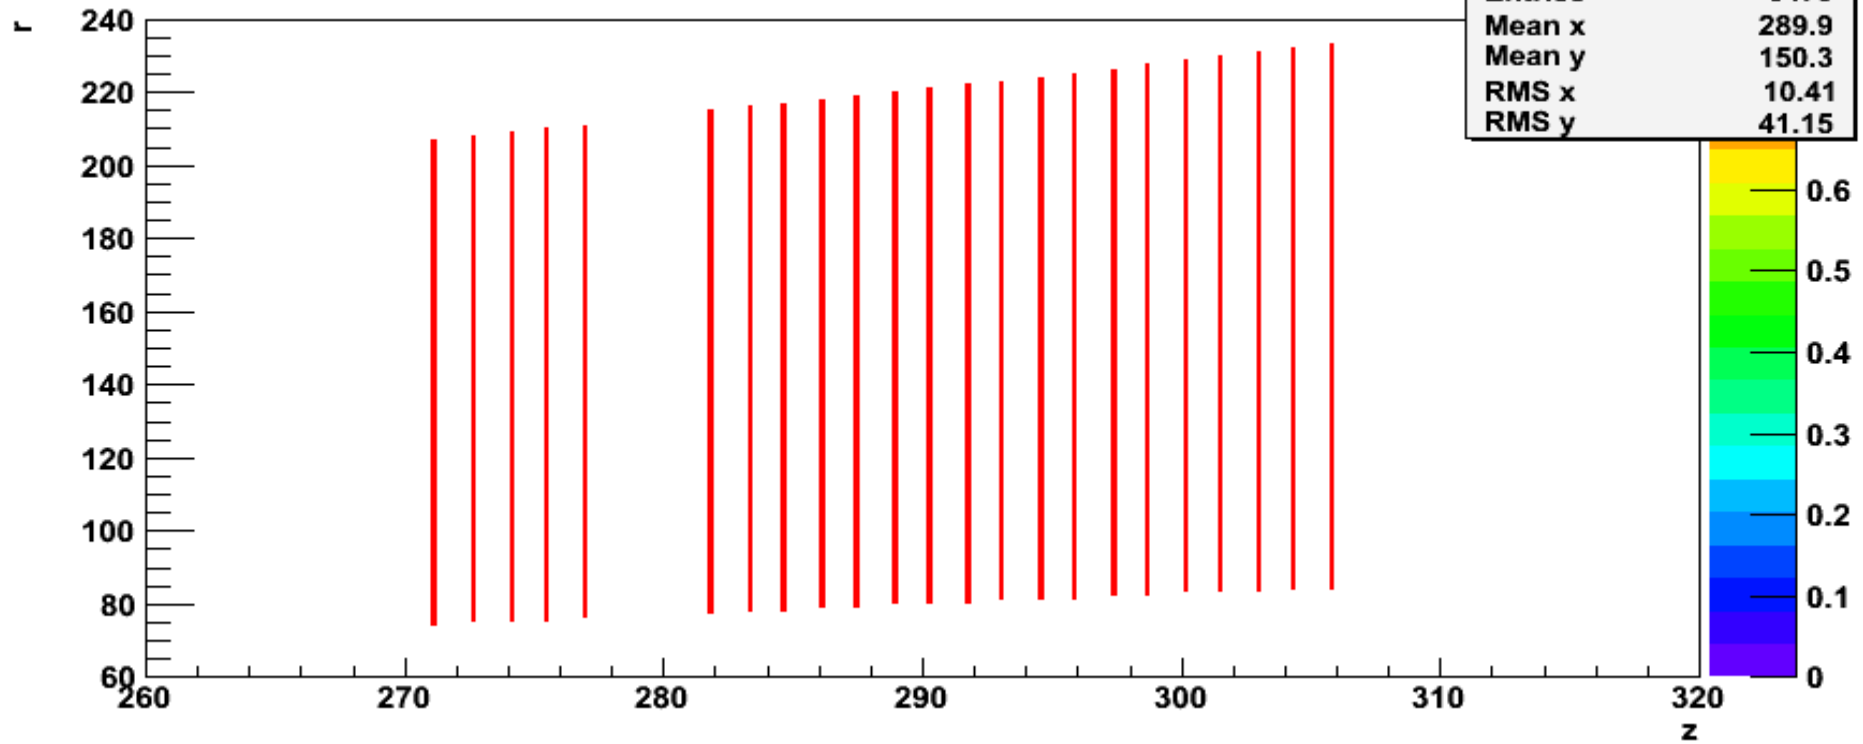
Material ECAL\_PBALLOY in rad.len

- 1) All 23 lead radiators show up.
- 2) Expect 0.8 radiation lengths
- 3) See 0.8 radiation lengths for each radiator

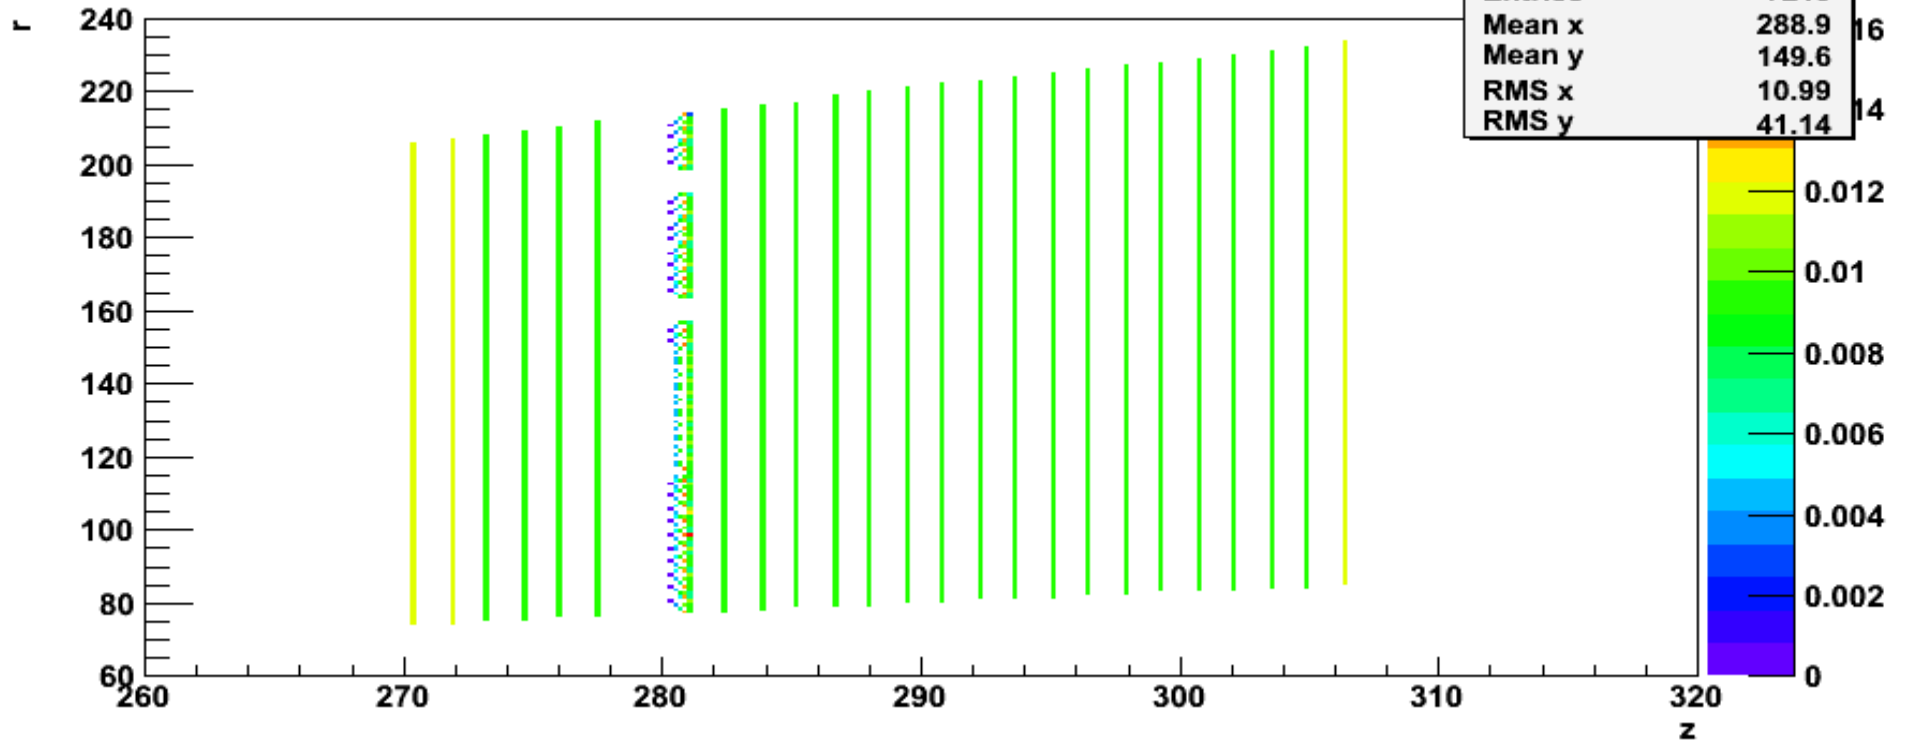
Material ECAL\_SCINT in rad.len

- 1) See all 24 megatiles with ECAL\_SCINT as material
- 2) See one SMD planes, EXPECT 2  
(at least we see the notches)
- 3) See correct ratio between preshower and normal tiles
- 4) Expect and see 0.012 radiation lengths for preshower tiles. Expect 7/5 larger for geantinos passing through 0.7 cm apex-to-base in SMD. Peak rad. len. is about 1.68 as expected.
- 5) Postshower shows correct number of radiation lengths.

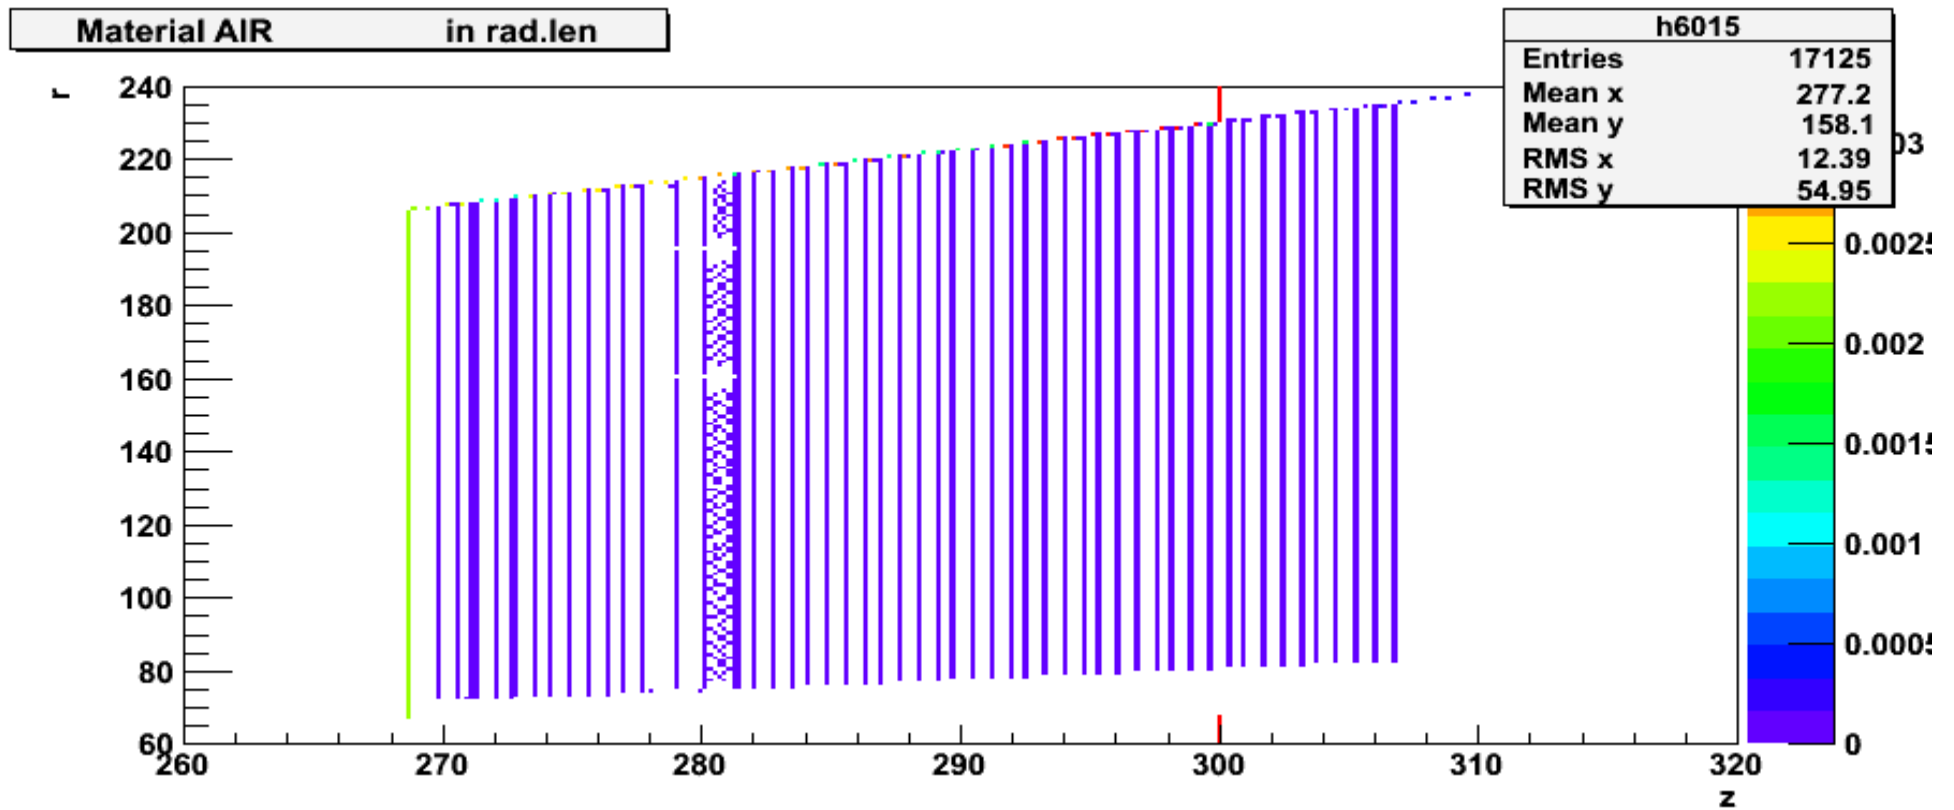
- 1) Air is air
- 2) Air is missing from the spacer layer
- 3) Looks like there are small airgaps between each SMD strip. Also may be some air in places where front/back plastic should be in the SMD plane... Not clear why, because....

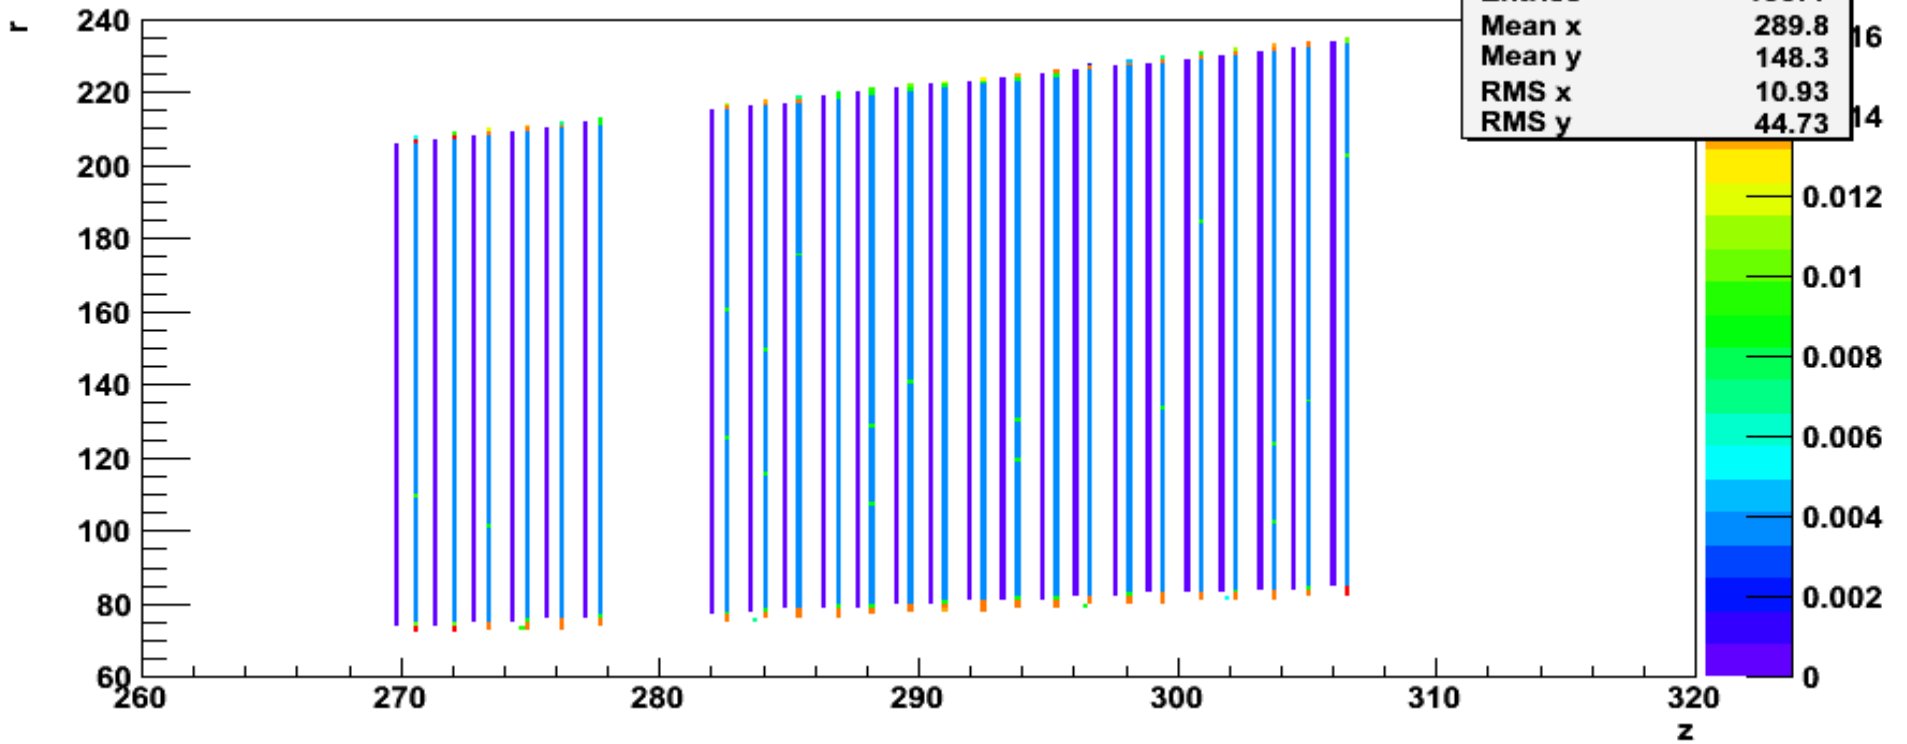
Material POLYSTYREN in rad.len

- 1) Polystyrene layers (i.e. fiber router in each megatile)
- 2) Should be uniform layer to layer.
- 3) Non uniformity due to fraction-of-1-mm shifts to align megatiles and radiators with as-built values.

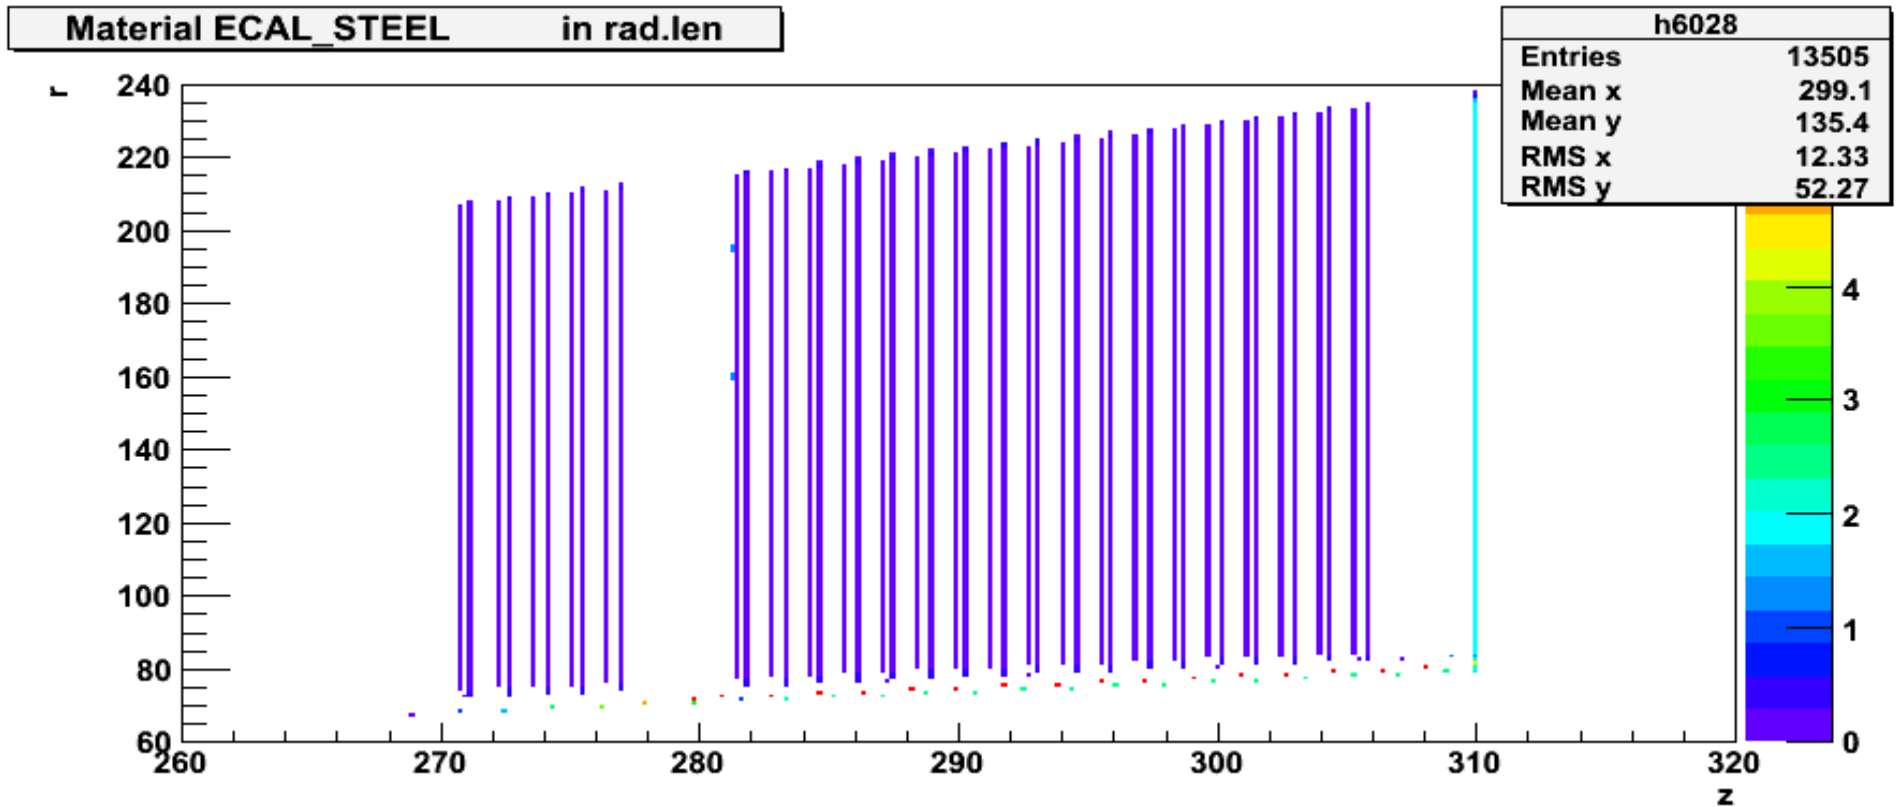
- 1) Steel cladding shows up around each radiator (23 pairs)
- 2) Scale is misleading here... zooming in on the histogram shows cladding is  $\sim 0.03$  radiation lengths, in line with value expected for 0.5mm of steel
- 3) Back plate shows up, expect and see 1.8 radiation lengths for 3.175 cm of Aluminum (aluminium if you prefer...)
